Helicopter Crashes Caused by Freewheel Disengagements

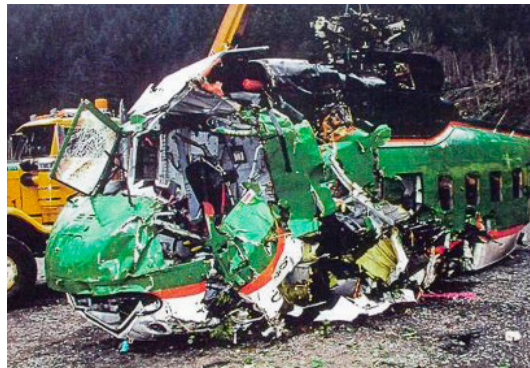
There have been some helicopter crashes where the freewheel suddenly disengaged leading to an engine over-speed and subsequent shutdown. Freewheel damage was moderate so the rotors could still turn freely, but autorotation was unsuccessful because of an operational factor such as low altitude or high rate of ascent. In the Sikorsky accident shown in Figure 1, as well as in other accidents, the freewheel device meant to prevent an accident has instead caused one.

Figure 1. A Sikorsky helicopter engaged in heli-logging crashed after a freewheel disengagement.

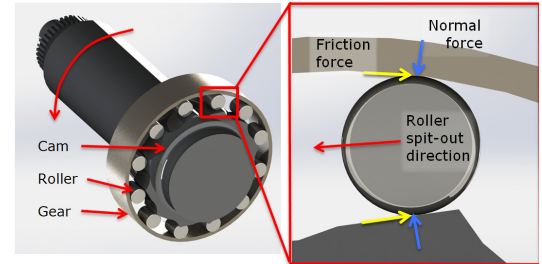
The freewheel of this Sikorsky helicopter consists of 12 rollers pinched between a flat cam on the engine side and a gear housing on the rotor side, as shown in Figure 2. When the engine applies torque, each roller is held in place by friction so long as the coefficient of friction (COF) is at least 0.06. If the COF is less than 0.06, the roller will slide off the cam flat. This is called a spit-out. A roller spit-out

often leads to a sudden freewheel disengagement at high engine load.

Figure 2. Left: The engine turns the cam causing the cam flats to pinch the rollers against the inside of a gear. That gear drives the main gearbox and ultimately the rotor. Right: If the coefficient of friction is less than 0.06 then the roller will spit out and the freewheel can disengage.

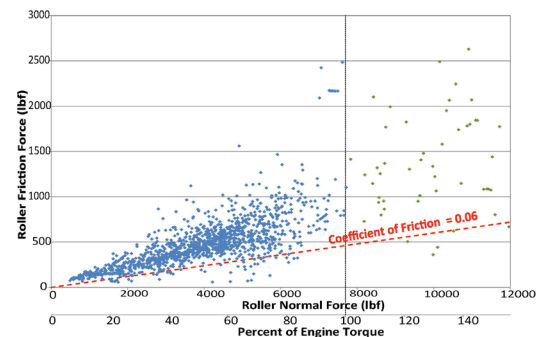
Engineers often assume that the COF between two materials is constant across all loading conditions. This assumption, however, is not always valid. Figure 3 shows data from more than 500 laboratory tests of the friction between the rollers and cams of this freewheel. The data show the COF is not constant and is sometimes less than the minimum value (0.06) needed to prevent a roller spit-out.

Figure 3. Each data point represents the normal and tangential load on a roller that slid on a cam flat in the laboratory. The line represents the coefficient of friction of 0.06 necessary to prevent roller spit-out. Data points below the line are where the COF is low enough for roller spit-out.

A low COF at high engine torque is believed to have caused freewheel disengagements that led to a number of crashes of this aircraft type engaged in heli-logging. Heli-logging is a repetitive external lift (REL) activity that this aircraft was not originally designed for.
