Fourier Transform Infrared Spectrometer (FTIR) Sample Case

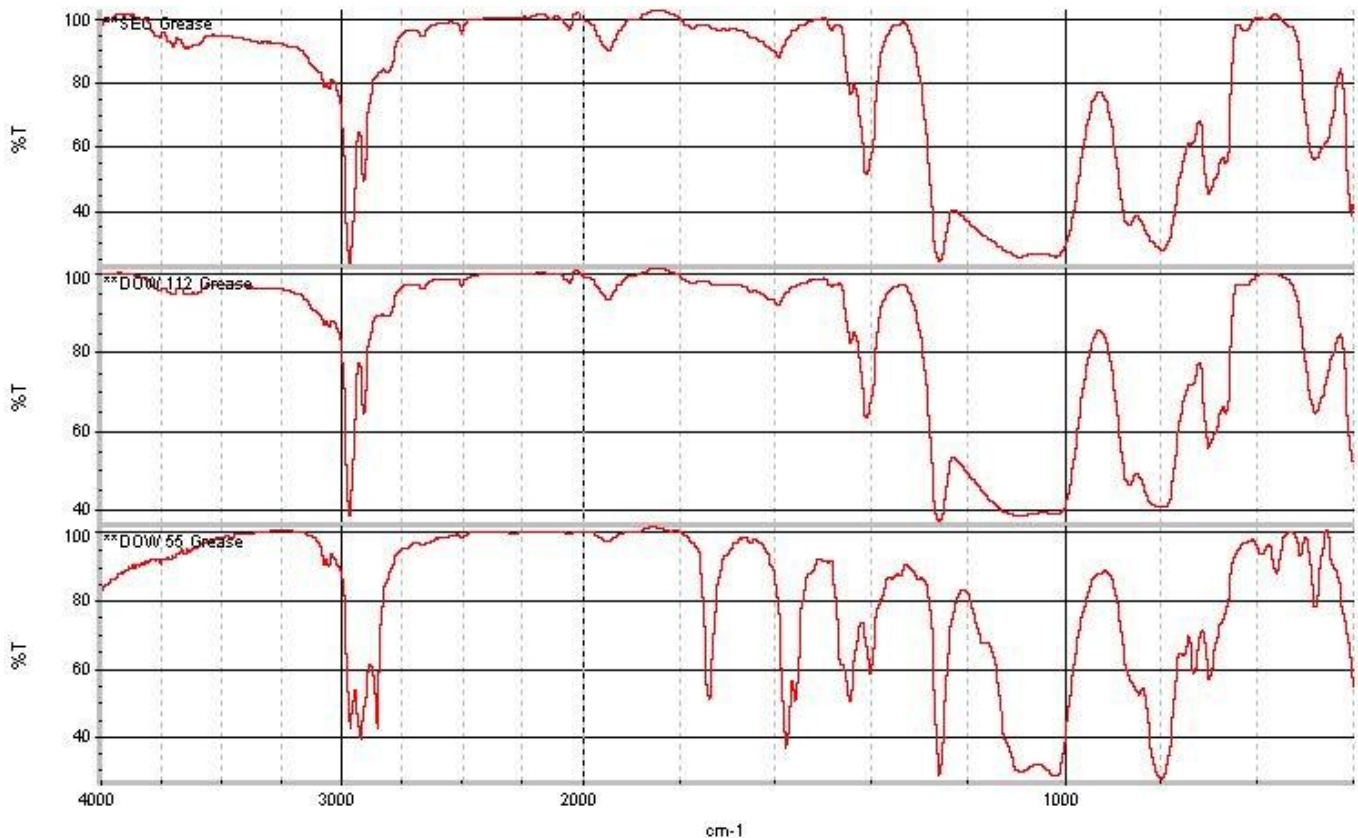
In one case, leaks in a fire protection system were traced to certain rubber O-rings that were not sealing properly. The cause was found with the aid of MEA's FTIR. Grease applied to the O-rings - a necessary step during installation - was the wrong one. The figure shows three FTIR spectra of O-ring grease. On the top is the grease specified in the installation instructions, in the middle is grease found on some of the non-leaking O-rings, and on the bottom is grease found on some leaking O-rings. The difference in the bottom spectrum clearly shows the wrong grease was used on the O-rings that leaked.
