Helicopter Crashes Caused by Freewheel Disengagements

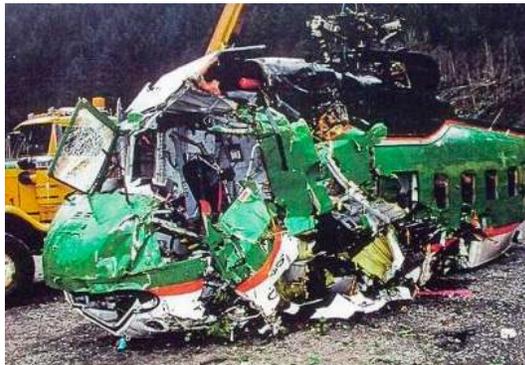
Figure 1. A Sikorsky helicopter engaged in heli-logging crashed after a freewheel disengagement.

A low COF at high engine torque is believed to have caused freewheel disengagements that led to a number of crashes of this aircraft type engaged in heli-logging. Heli-logging is a repetitive external lift (REL) activity that this aircraft was not originally designed for.

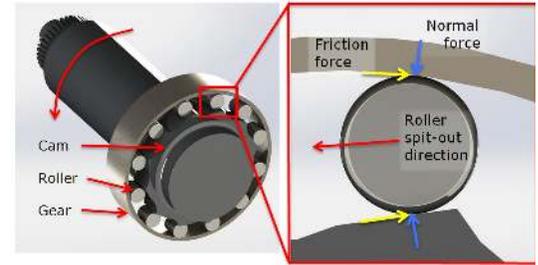
The freewheel of this Sikorsky helicopter consists of 12 rollers pinched between a flat cam on the engine side and a gear housing on the rotor side, as shown in Figure 2. When the engine applies torque, each roller is held in place by friction so long as the coefficient of friction (COF) is at least 0.06. If the COF is less than 0.06, the roller will slide off the cam flat. This is called a spit-out. A roller spit-out

often leads to a sudden freewheel disengagement at high engine load.

Figure 2. Left: The engine turns the cam causing the cam flats to pinch the rollers against the inside of a gear. That gear drives the main gearbox and ultimately the rotor. Right: If the coefficient of friction is less than 0.06 then the roller will spit out and the freewheel can disengage.

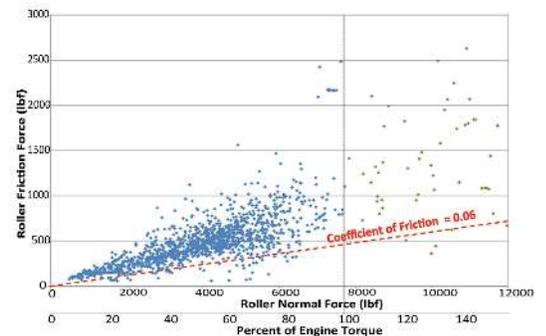
Engineers often assume that the COF between two materials is constant across all loading conditions. This assumption, however, is not always valid. Figure 3 shows data from more than 500 laboratory tests of the friction between the rollers and cams of this freewheel. The data show the COF is not constant and is sometimes less than the minimum value (0.06) needed to prevent a roller spit-out.

Figure 3. Each data point represents the normal and tangential load on a roller that slid on a cam flat in the laboratory. The line represents the coefficient of friction of 0.06 necessary to prevent roller spit-out. Data points below the line are where the COF is low enough for roller spit-out.
