# Wheel Separations

by Mark Bailey MASc, PEng, PE

As published in the *Advocate Journal of the Consumer Attorneys Association of Los Angeles (CAALA)*, November 2012

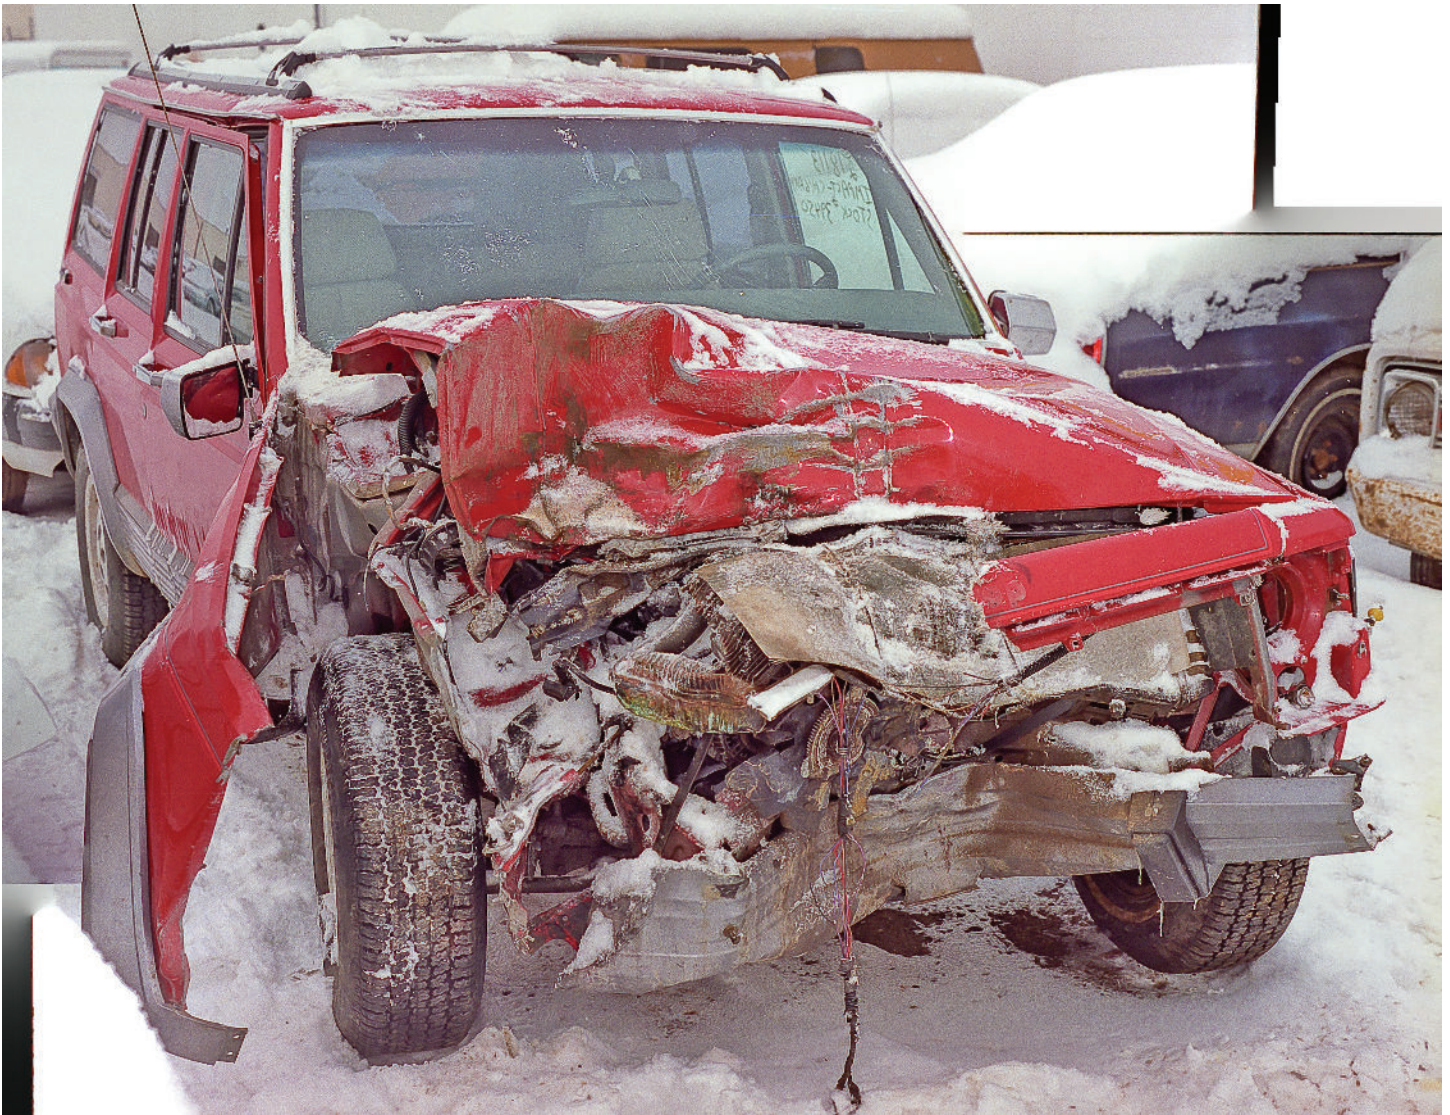
**Figure 1.** Front-end damage from head-on impact with separated dual heavy truck wheels.

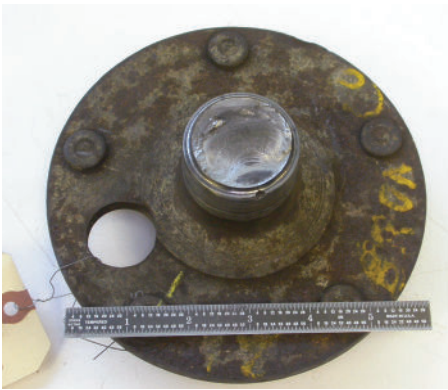
**Figure 2.** The end of a Ford Bronco axle broke off one month after it was serviced. During the service an axle bearing was carelessly removed with a cutting torch, which metallurgically altered the axle and led to a catastrophic fatigue fracture.

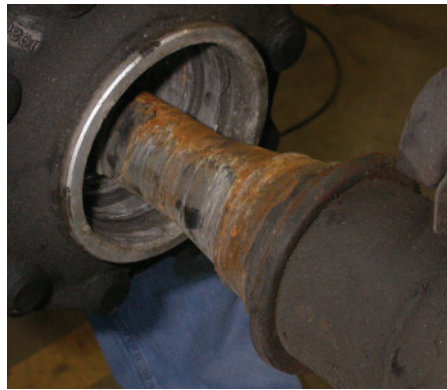
**Figure 3.** A heavy truck hub had a bearing failure and the consequent friction destroyed the hub and allowed it to come off the end of its axle.

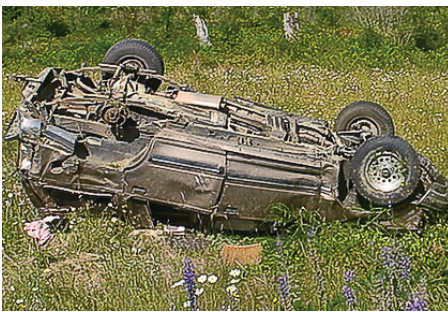
**Figure 4.** Eyewitnesses observed the left rear wheel separate from this SUV before it lost control and rolled. All five nuts were missing from the wheel studs of the left rear wheel.

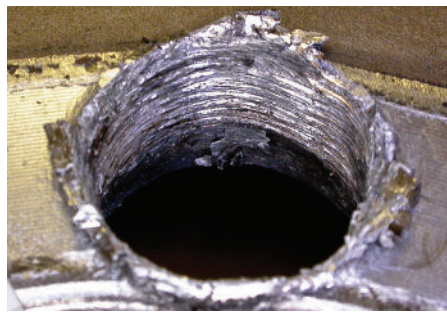
Figure 5 shows a wheel stud and the hole of the left wheel that it was in. The nut has spun off the stud and was never found. The

stud threads left an imprint in the aluminum wheel and there is aluminum embedded in the stud threads. The stud is not broken.

**Figure 5.** This stud (right) and wheel hole damage (above) is from a left-side wheel separation that occurred 21 days after the wheel was installed.

The mechanism for the left side wheel nuts spinning off as the vehicle travels can be understood from the geometry of the wheel and studs when the wheel is slightly loose. Since the stud holes are larger than the studs, the wheel is not perfectly concentric with the axle when the nuts are loose. When the road pushes up on the tire, the wheel tends to be pushed up relative to the axle centerline. This means the wheel centerline is slightly above the axle centerline. This centerline offset gives rise to a relative velocity vector between each wheel nut and the part of the wheel the nuts touch. This vector is in the loosening direction on the left side when the vehicle is driving forward and is the cause of wheel nuts spinning off the left side.

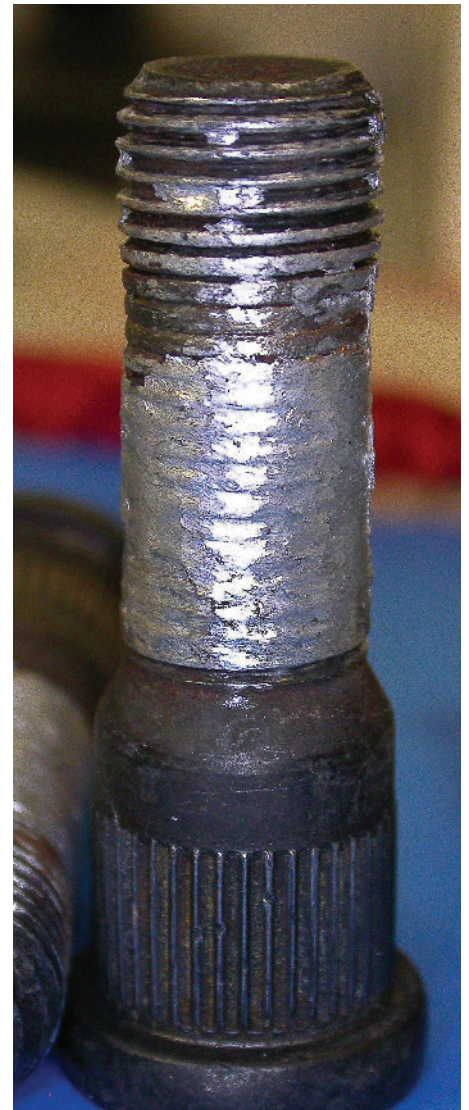
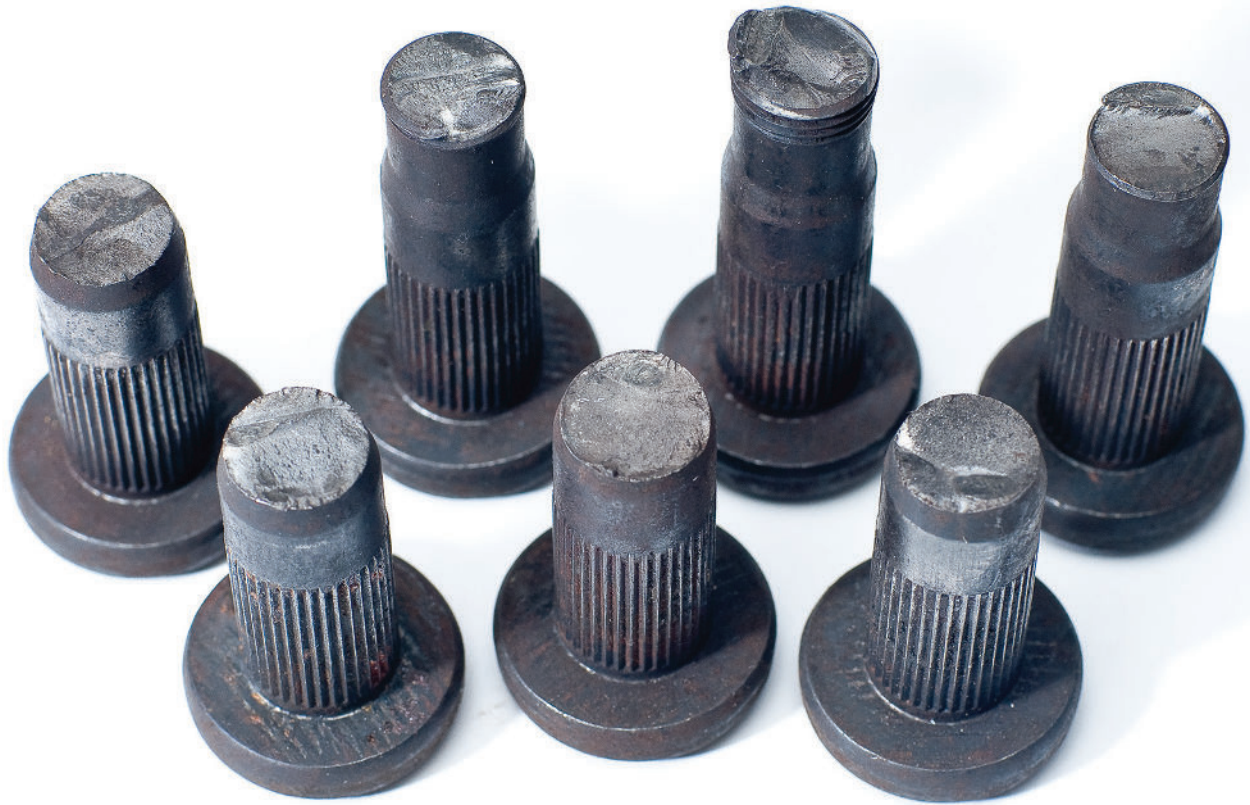
Figures 6 and 7 show broken right side wheel studs. These are the portions of the studs that were in the wheel hub. The parts of the stud that broke off, along with the nuts, were never found. The flat fractures with "beach marks" (fine curved parallel lines resembling an aerial view of a beach) on the fracture surface are typical of right-side stud fractures, and are classic examples of what engineers refer to as reversed bending fatigue.

**Figure 6.** Fatigue fractures on studs from a motor home right-side wheel after 2900 miles. Fatigue fractures are usually flat and transverse to the stud axis.

right side, a loose nut tends to stay loose rather than spin off. But this invites another mechanism – fatigue. When a nut is tight, the clamping force creates large frictional forces at the wheel/hub interface that transfer the vertical forces that support the weight of the car. However, when a nut is loose, there is no clamping force, and the studs now carry the vertical forces. This bends the studs up and down every time the tire rotates. Just as a paper clip breaks when you bend it back and forth a few times, a wheel stud can break when it is bent up and down a few million times. This is called reversed-bending fatigue, and is the reason that right-side studs eventually break off when the nuts are loose.

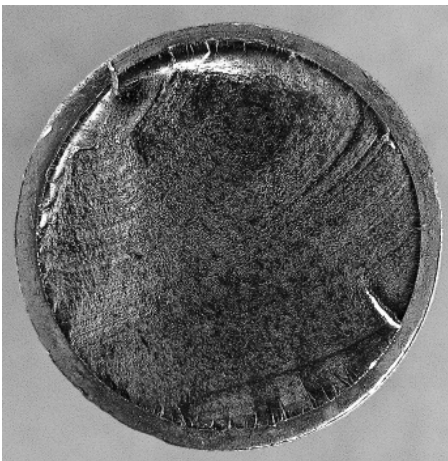
**Figure 7.** Beach marks on the fracture surface are clear signs that this stud from the right rear of a van failed from fatigue. Failure was less than 121 days since installation.

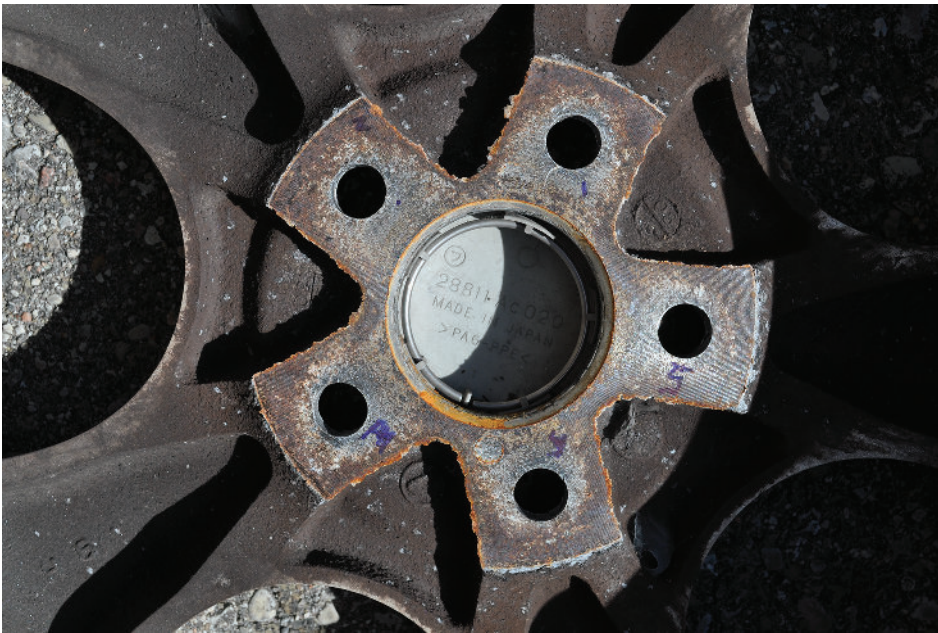
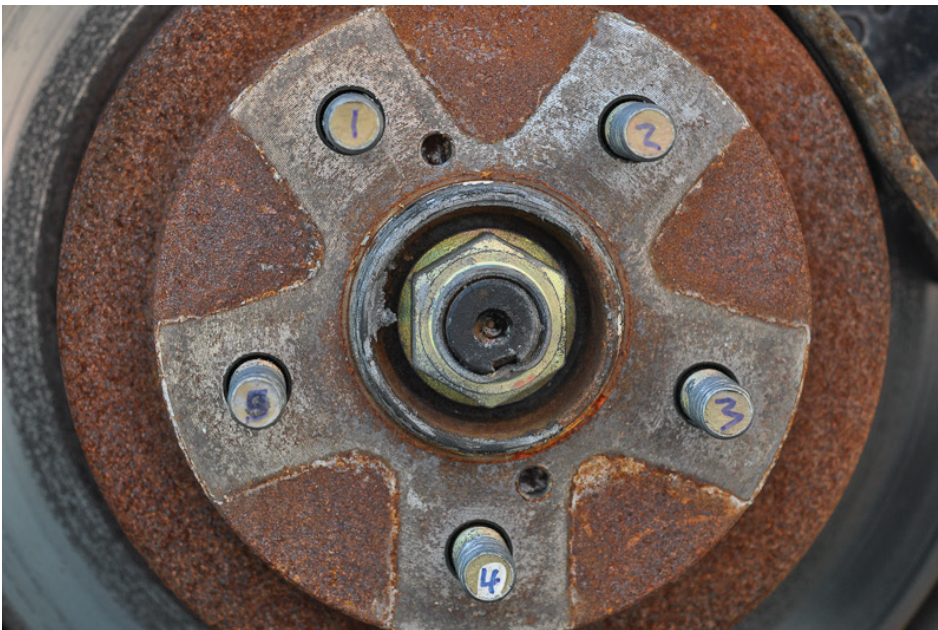
**Figure 9.** The minor rust deposits on the edges of the contact area of this aluminum wheel are normal, but the contact patch (five white arms outlined by rust) on the brake rotor must be clean.

Figure 9 shows an example of corrosion (visible as orange-brown iron oxide) from an iron brake rotor on a passenger car with aluminum (or "alloy") wheels. In this case the corrosion developed on the iron brake rotor in the exposed spaces where the aluminum wheel flange did not press on the rotor, leaving a clean contact patch or "footprint" of the wheel flange on the rotor. The corrosion is not problematic unless it develops on the clean footprint area. If the footprint was corroded instead of clean, as shown in Figure 10 for a steel wheel that separated, then the rust clamped between the wheel and rotor is thinned by crushing from driving, leading to lost clamping force. There are ample warnings for wheel installers to clean wheel surfaces before re-installing a wheel to prevent corrosion and dirt from imperiling the clamping force. Cleaning the wheel interfaces is normally done with a wire brush just before installation.

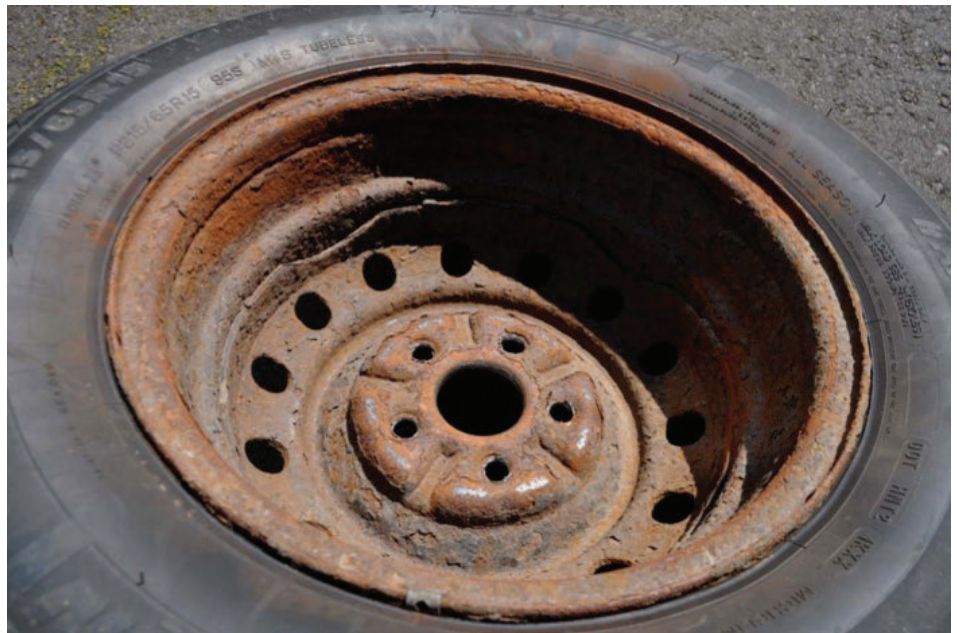
**Figure 10.** A badly corroded wheel separated because rust deposits were not cleaned off properly before it was installed.

The remedy to the wrong or lost clamping force is to have the wheel nuts re-torqued after a short driving distance. Although wheel separations are rare, they should be entirely preventable with re-torquing.
