Break a leg:

The ins and outs of analyzing pedestrian collisions

by John C. Gardiner PhD PE, and Check Y Kam MS PE

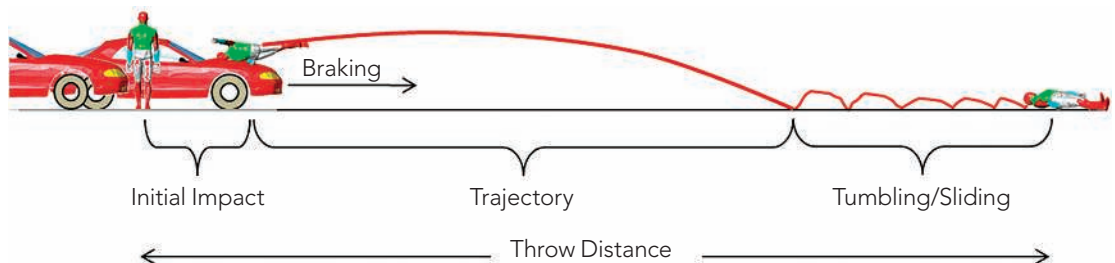
Figure 1: Phases during a typical forward projection vehicle-pedestrian collision with braking of the striking vehicle.

There are generally three distinct phases during a vehicle-pedestrian collision (Figure 1). The first phase is the initial impact, during which the pedestrian wraps around the front end of the vehicle and/or is carried by the vehicle. The second phase is the trajectory, during which the pedestrian separates from the vehicle and is projected forward of the vehicle. The third phase is the ground contact, which involves a combination of rolling, tumbling and/or sliding on the ground until the pedestrian comes to rest. The distance from the point of initial impact to the final rest position of the pedestrian is defined as the total pedestrian throw distance.

projected forward and comes to rest ahead of the vehicle (as illustrated in Figure 1).

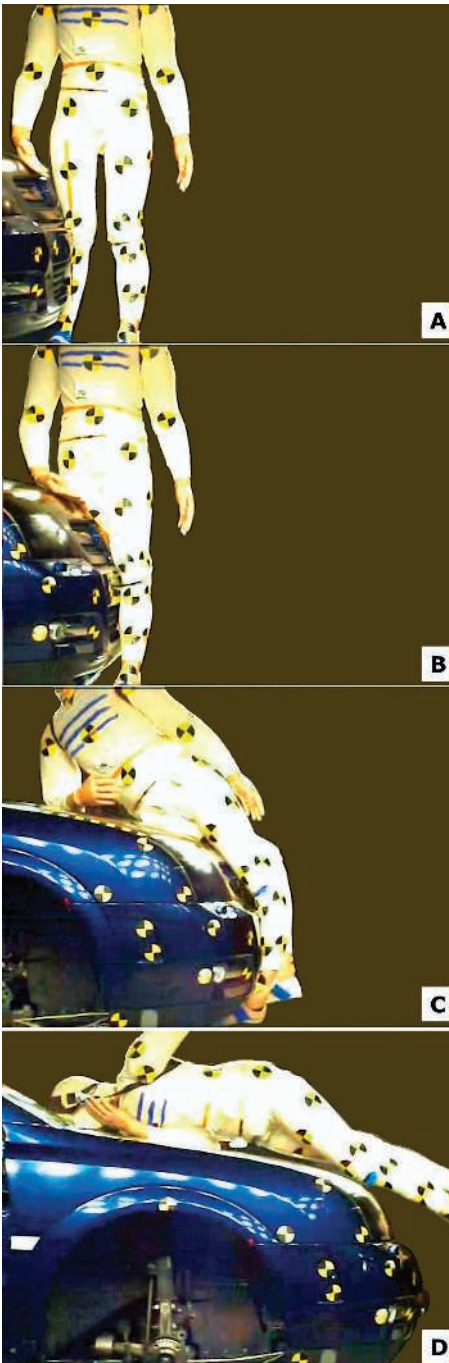
Figure 2: Image sequence showing the initial impact phase of vehicle-pedestrian collision at 25 mph. This collision resulted in a forward projection.

When the front bumper of a vehicle first contacts with the lower extremities of a pedestrian, the legs are rapidly accelerated up to the speed of the vehicle while the head and torso of the pedestrian remain relatively still (Figure 2A). As the vehicle continues to move forward, the lower extremities begin to wrap around the contour of the front end of the vehicle (Figure 2B). The pelvis and torso of the pedestrian then begin to rotate and wrap around the front end and hood of the vehicle (Figure 2C) until the head strikes the vehicle (Figure 2D). Typically, head strike occurs on the hood or windshield, but the exact impact location depends on variables such as pedestrian height, vehicle geometry, and impact speed.

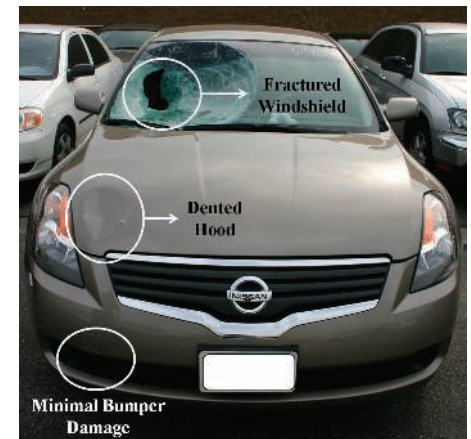
Figure 3: Forward projection impacts generate a typical damage pattern that includes front bumper damage, a dented hood, and a fractured windshield.

The type of vehicle-pedestrian interaction can often be established from the vehicle damage. For forward projection impacts, the vehicle typically has damage to the front bumper cover consistent with initial leg contact, a dent close to the leading edge of the hood consistent with hip or pelvis contact, and a dent at the top of the hood or fracture at the base of the windshield consistent with head strike (Figure 3).
